ROLLER SIDE COVERS FOR MUNCIE TRANSMISSIONS

AUTO GEAR EQUIPMENT

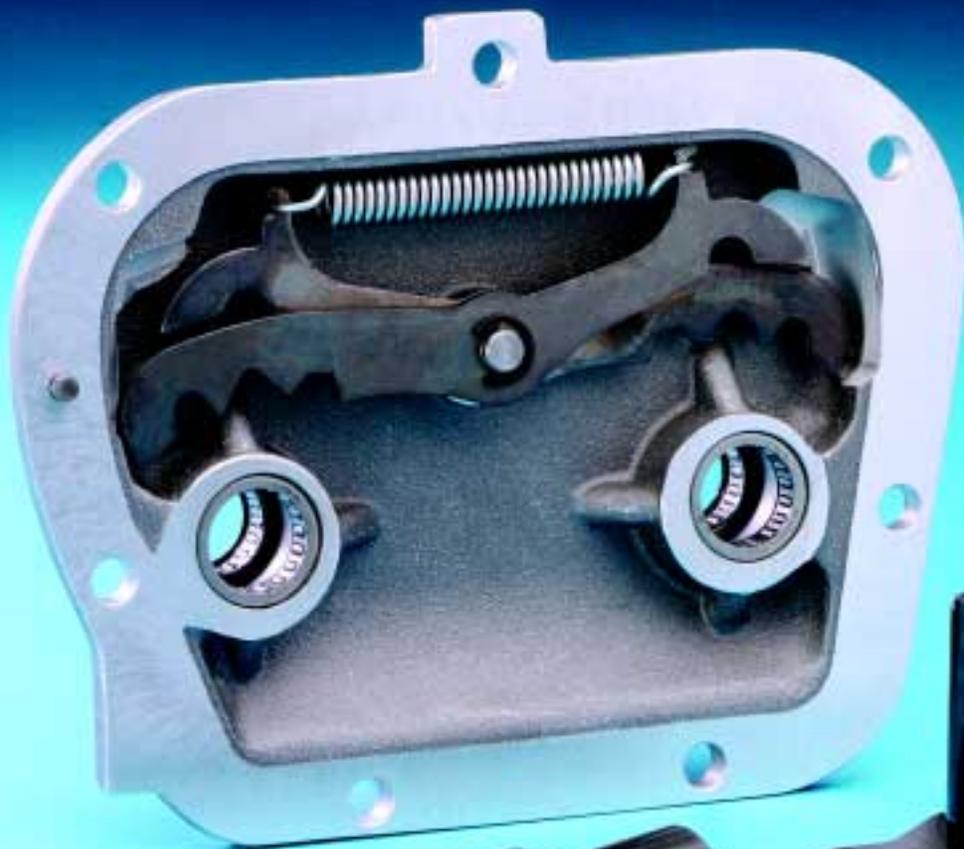
We noticed that we sell more side cover oilseals for Muncies than synchronizer rings, and although the oilseals are inexpensive and easy to replace, this bothered us. When we investigated we discovered that the shifter shafts in many high-mile side covers are running in elongated bores, causing new oilseals to fail prematurely.

Obviously, a new side cover with round bores would solve the problem temporarily, but we wanted a permanent solution, so we made our shifters a true .750" (the OE shafts seem to be a few thou smaller) and supported them with needle bearings. It's standard on our new transmissions and available as a kit for your existing Muncie.
